Planned Preventative Maintenance Survey Report

Property Address: Barley Hill House.

Clients Name: Beaver House (Management) Ltd.

Date of Inspection: Tuesday 20th October 2020

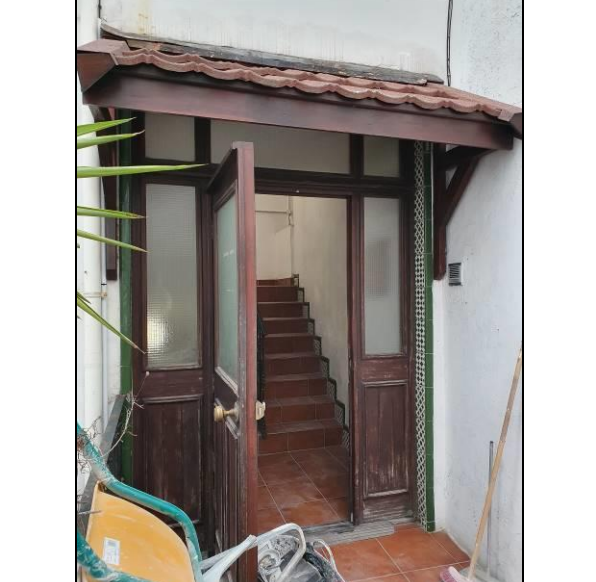
B	 	<p>Cracked concrete and exposed re-bar. When the re-bars corrode it expands hence the cracking of the concrete.</p>
B	 	<p>Perished varnish to timber door, in order to protect the timber from the elements it's advisable to re-treated the timber.</p>
B

<p>As above.</p>

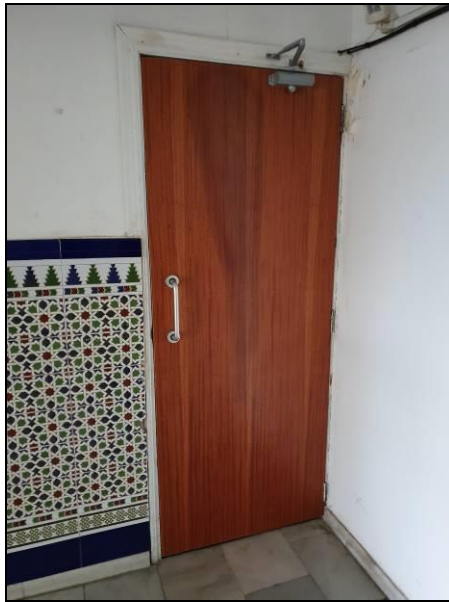
D

Door is in good conditions but it's not suitable for its location in the building which makes it uncompliant with current local regulations.

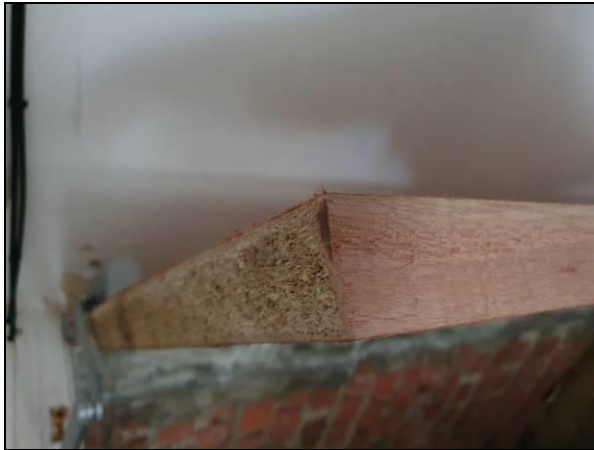
D

As above.

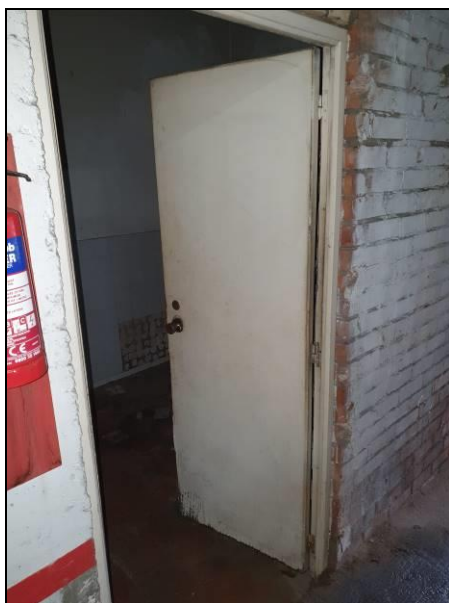
C

Bin store timber door and frame in poor conditions.

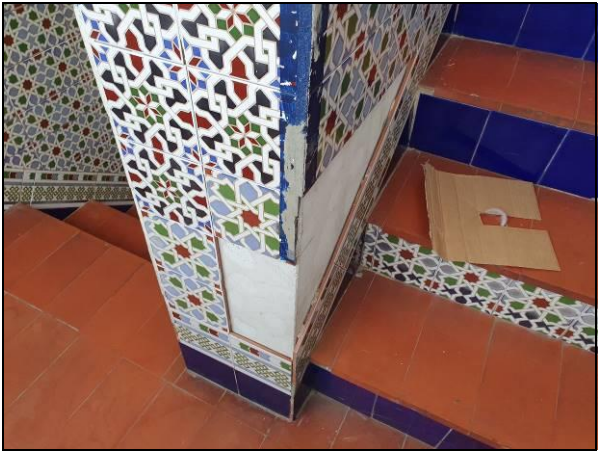
C

Floor and wall tiling throughout the building in poor condition, trip hazard and in some areas especially in the exposed corridors could lead to water penetration.
C

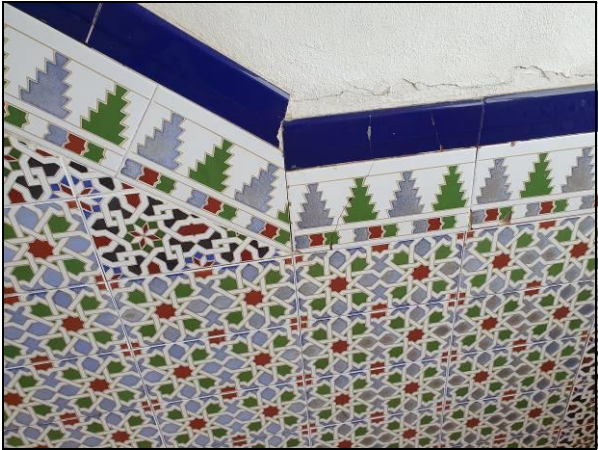
As above.
C

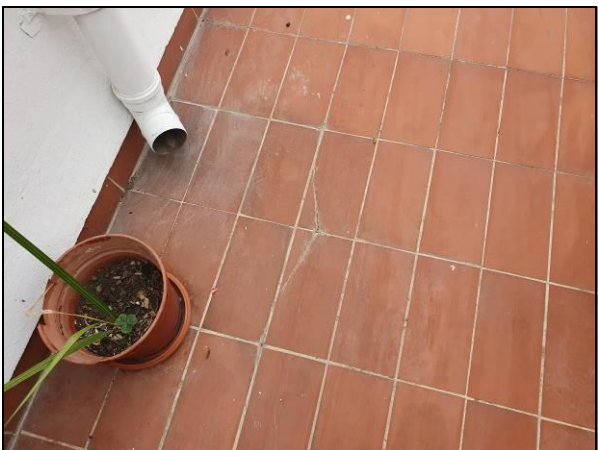
As above.

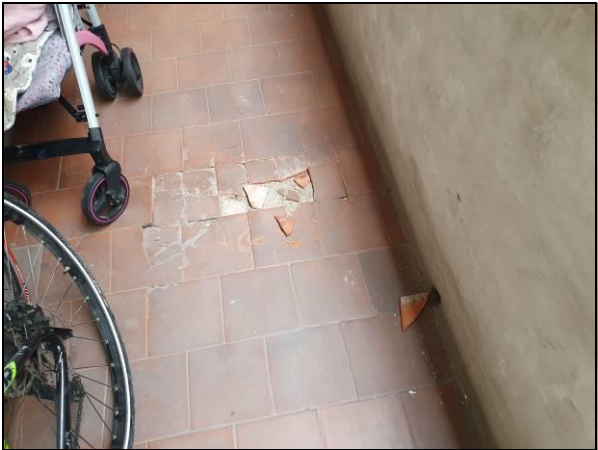
C

As above, this area are the most important areas to action as it could lead to water penetration.
C

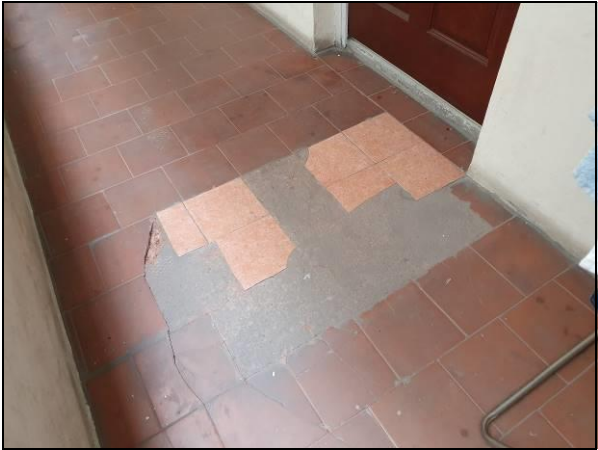
As above.
B

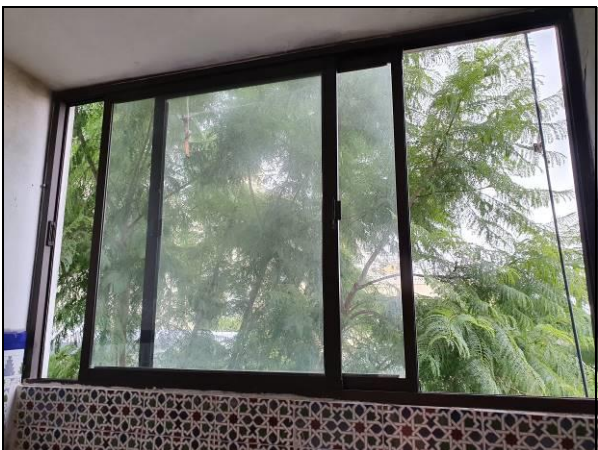
Windows in fair conditions but sliding mechanism is failing.

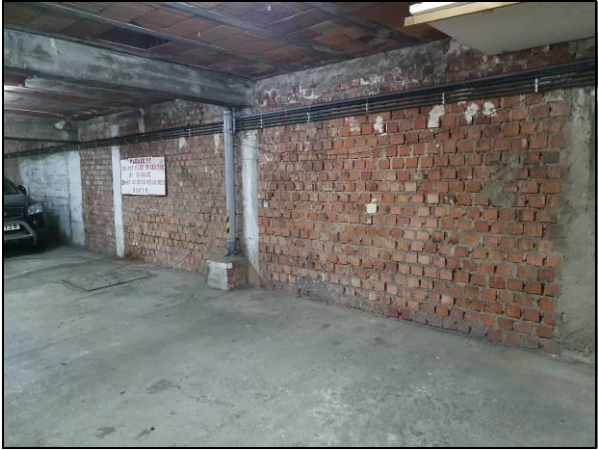
C

<p>Walls to garage area in very poor aesthetic condition.</p>
C

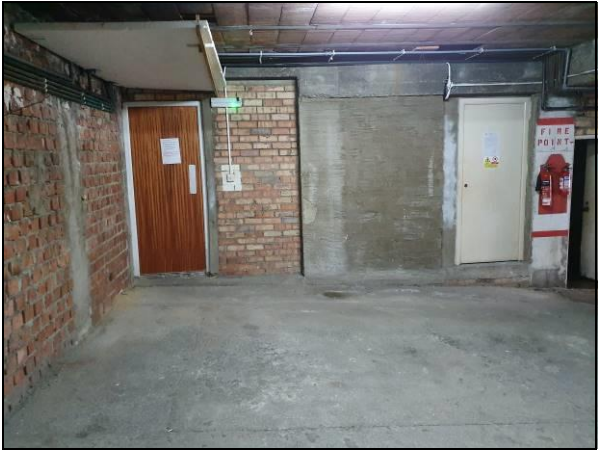
<p>As above.</p>
D

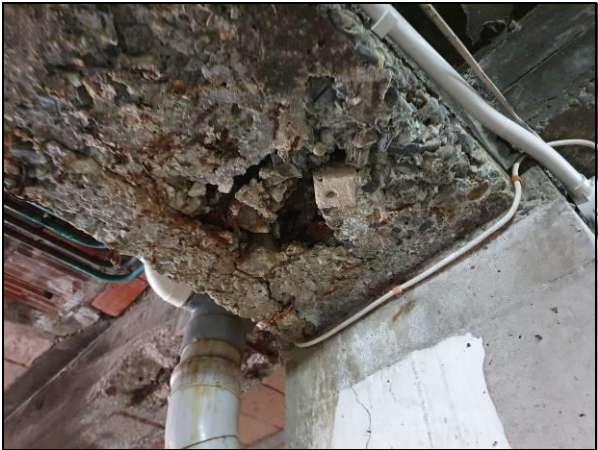
<p>Due to the copper water pipes water has been penetrating through the concrete and causing re-bars to corrode. It's advisable for this to be taken care of as soon as possible.</p>

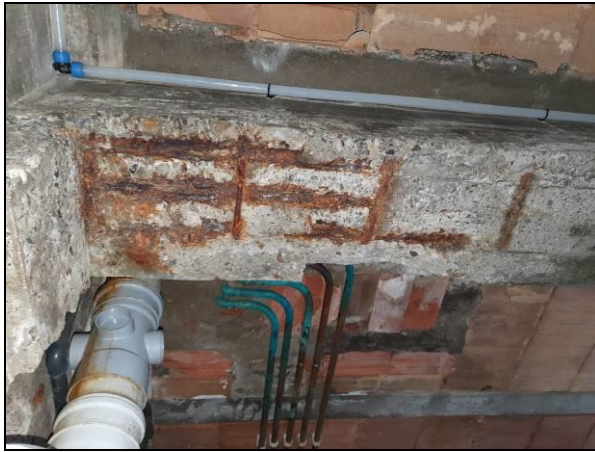
D

As above.

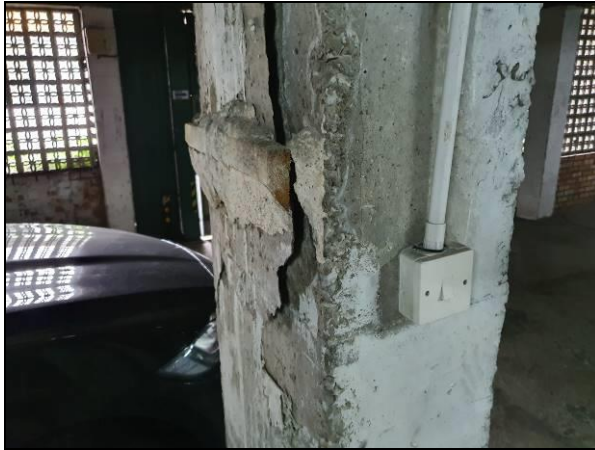
D

As above.

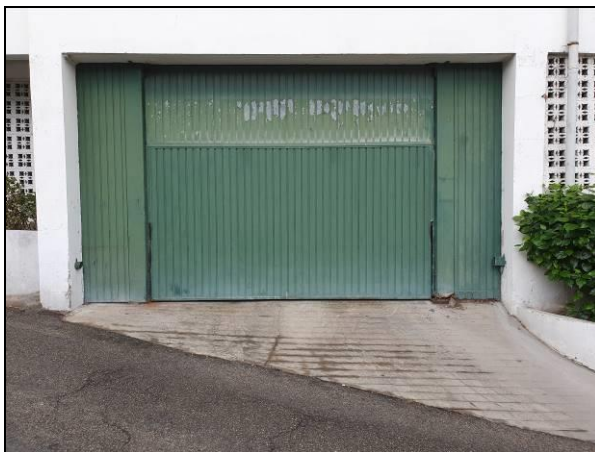
C

Garage door in fair condition apart from the bottom part to the right hand side, close up photo below.

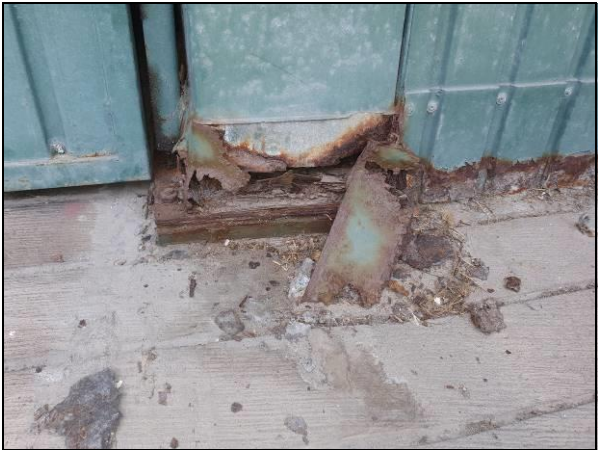
C

<p>Continued from above, it's advisable for this to be taken care of as soon as possible to prevent any further corrosion to the steel.</p>
B

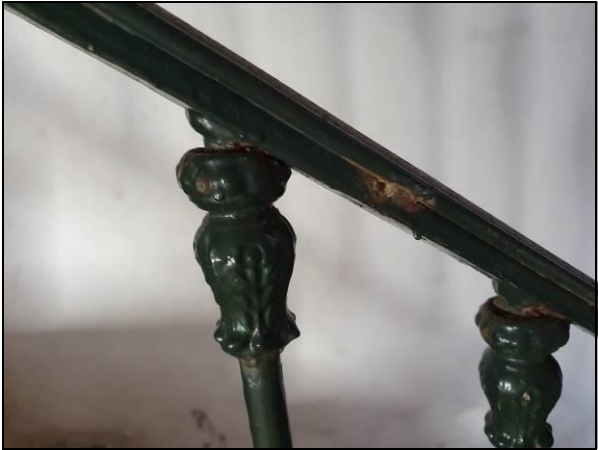
<p>Balustrade in good conditions but corrosion is starting to appear.</p>
B

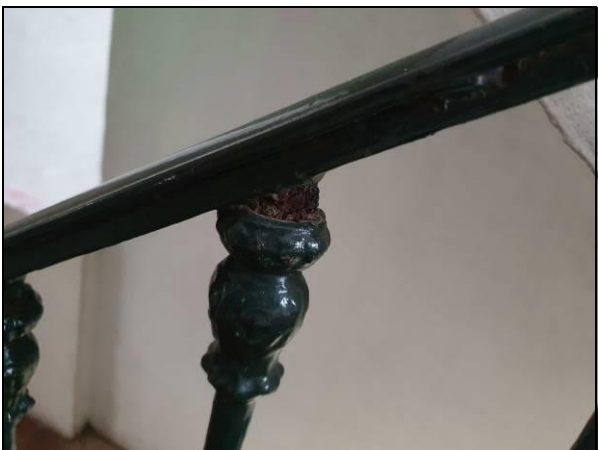
<p>As above.</p>

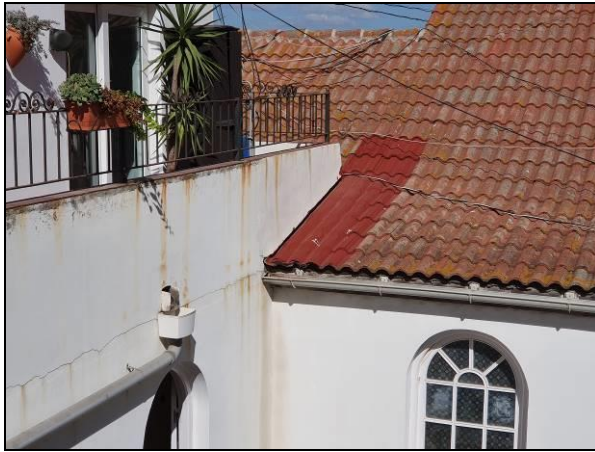
D

Area of roof with water ingress issue, to be actioned as soon as possible.

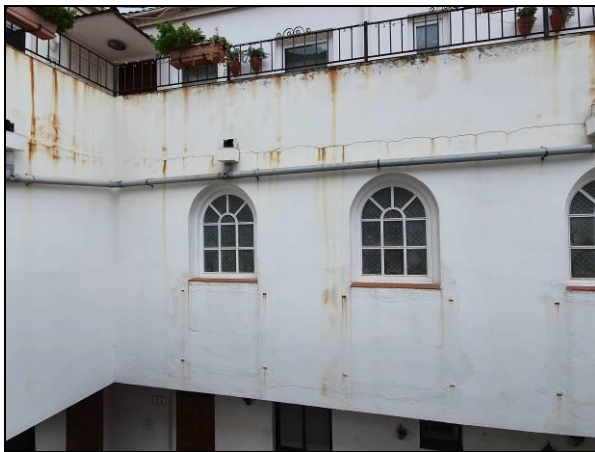
C

Façade throughout the building in poor conditions. Rust stains starting to appear from the re-bars. It's advisable for the façade to be re-rendered as soon as possible in order to prevent severe damage to apartments.

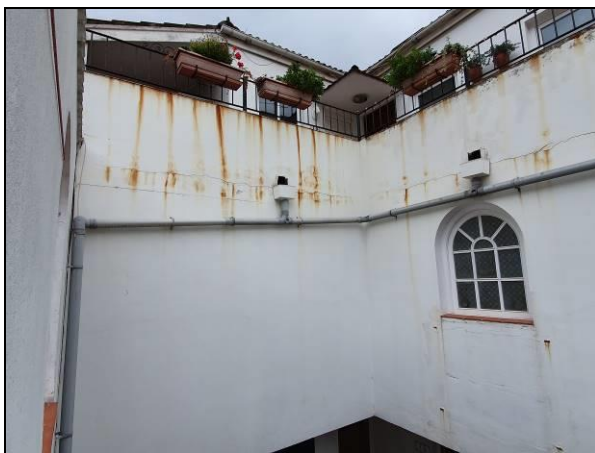
C

As above.

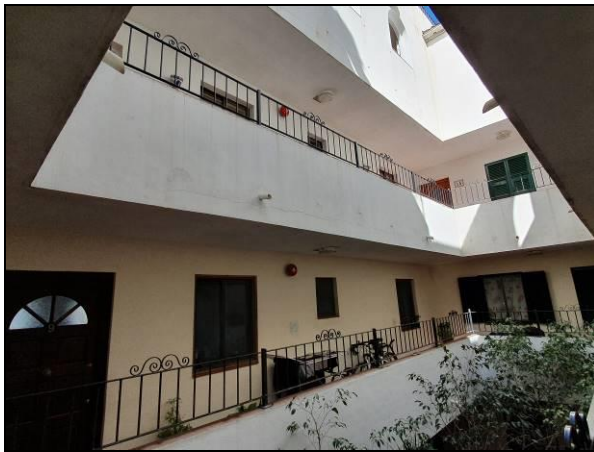
C

As above.

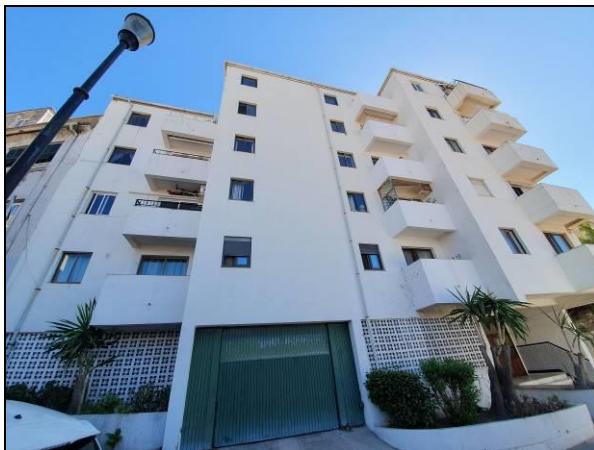
C

As above.

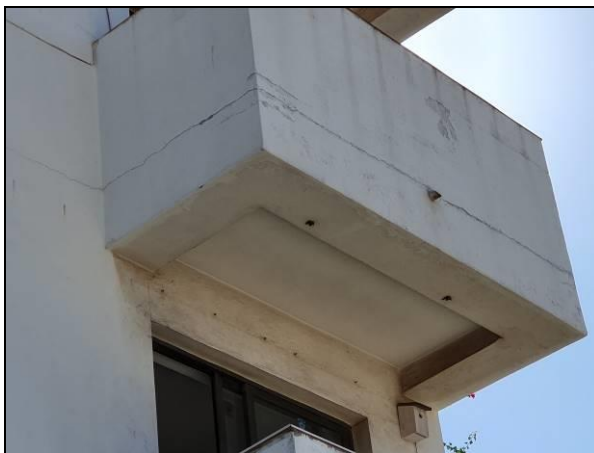
C

As above, all cracks throughout the façade are at the joints where the brick walls meet the floor slabs. This kind of cracks are common to appear when the render starts failing. It's not a structural issue.

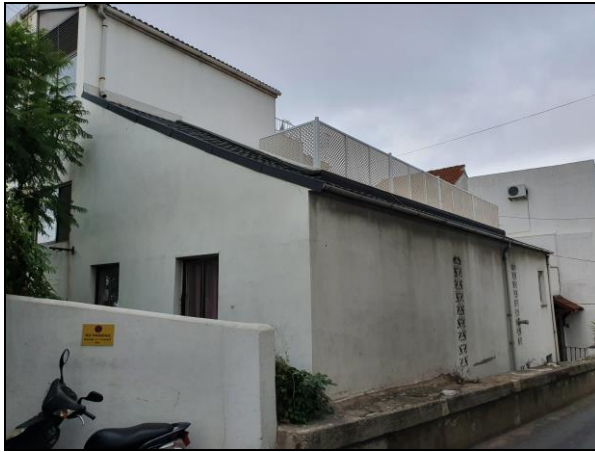
C

As above.

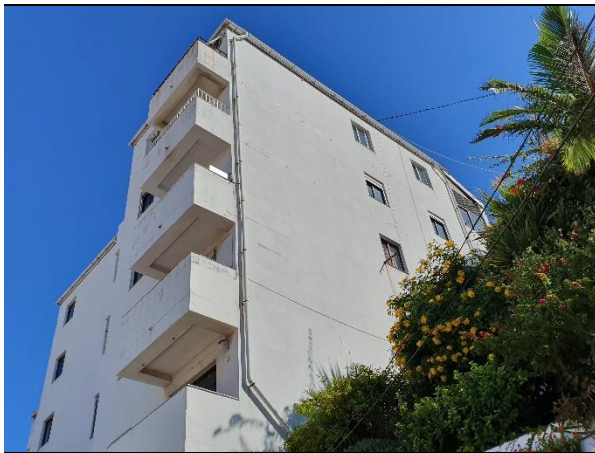
C

As above.

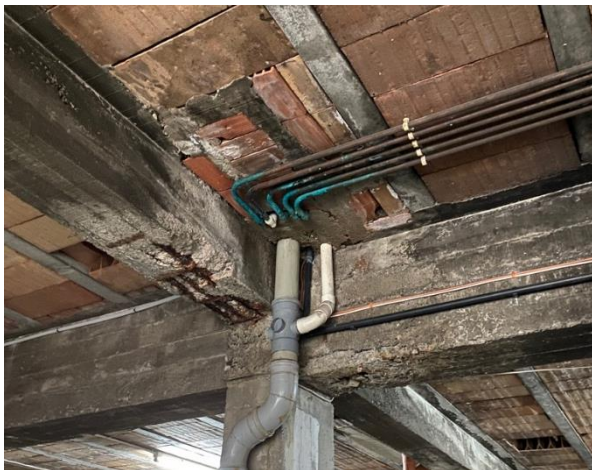
D

Plumbing throughout the building in very poor conditions. Copper pipes are starting to deteriorate causing leaks throughout the building.

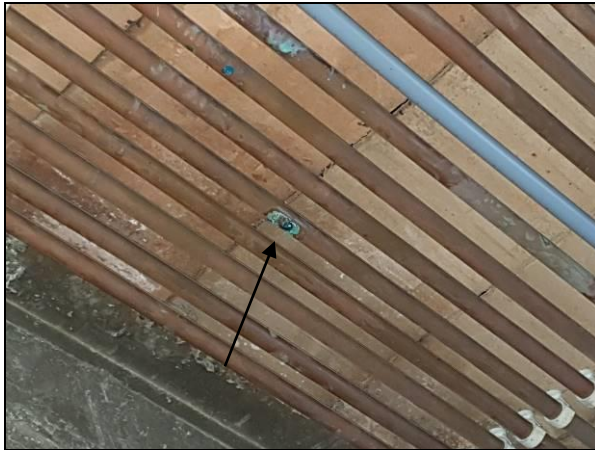
D

As above, around shows small hole in pipe with a constant drop leak.

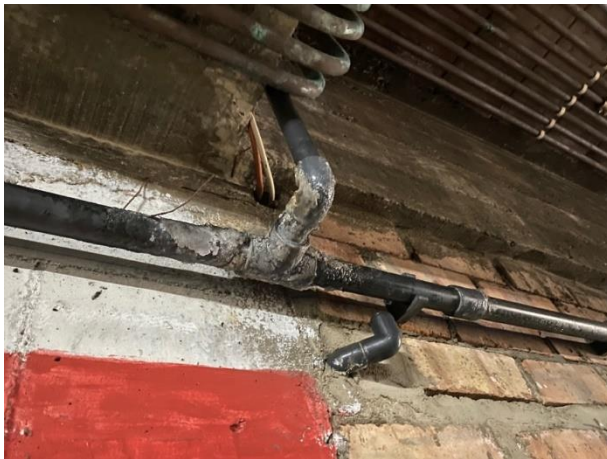
D

Some of the plastic pipes are also in poor condition. It's recommended for all plumbing throughout the building to be addressed accordingly.

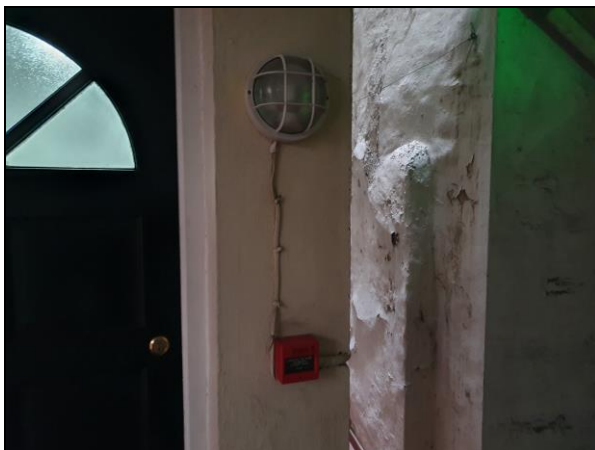
D

Faulty light fitting

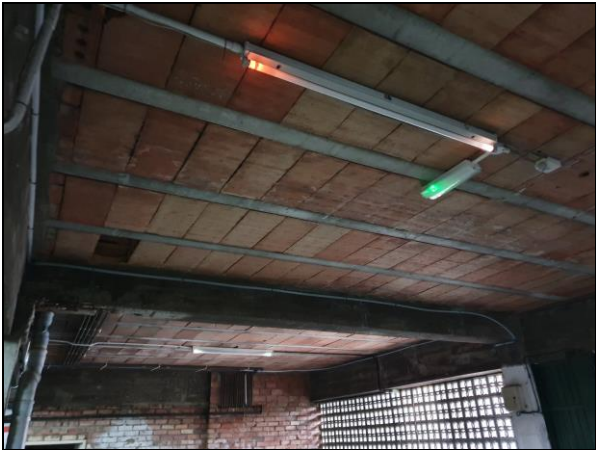
D

Faulty fluorescent light fittings

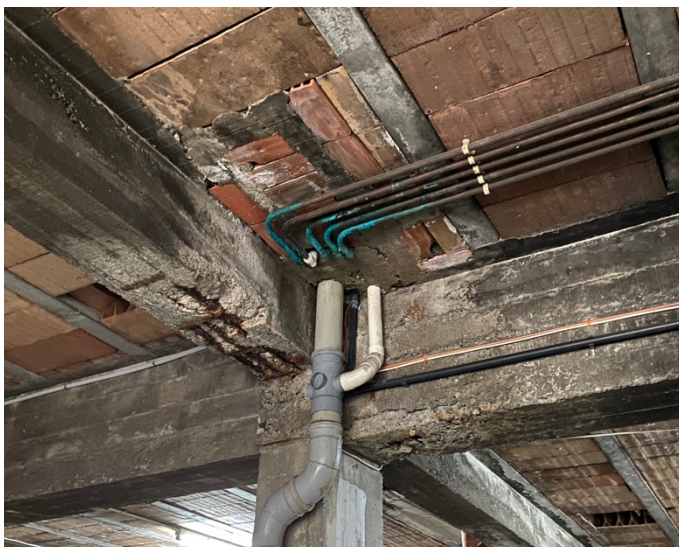
IMG1

The mains water supply pipework feeding each individual flat leaving the meter room and within the garage is generally in poor condition. The pipework throughout the garage mainly consists of 22mm copper pipework which is showing major signs of corrosion and a number of repairs have already been undertaken using clamps. From the garage, the pipework then runs vertically up through the building in risers which are accessed through the apartments. Whilst not all the risers were accessible at the time of the survey, viewing two of the riser shafts on the east side indicated that the copper pipework within the risers had been replaced for 15mm polybutylene (acorn). Two further risers (north and west areas of the building) were not accessible at the time but it is presumed that this pipework was also renewed.

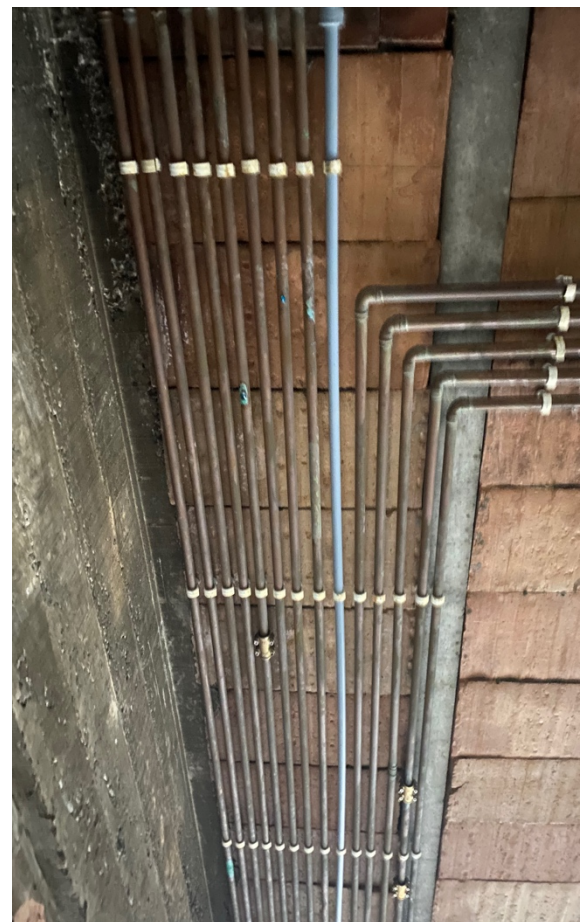
IMG2

It would be advisable to replace all remaining copper within the garage (img2) to avoid any further problems although this would be the responsibility of each individual owner within most standard underleases. The concrete surrounding the supply pipework (img1) is showing significant damage, most likely caused by defective copper pipes penetrated through the slab.

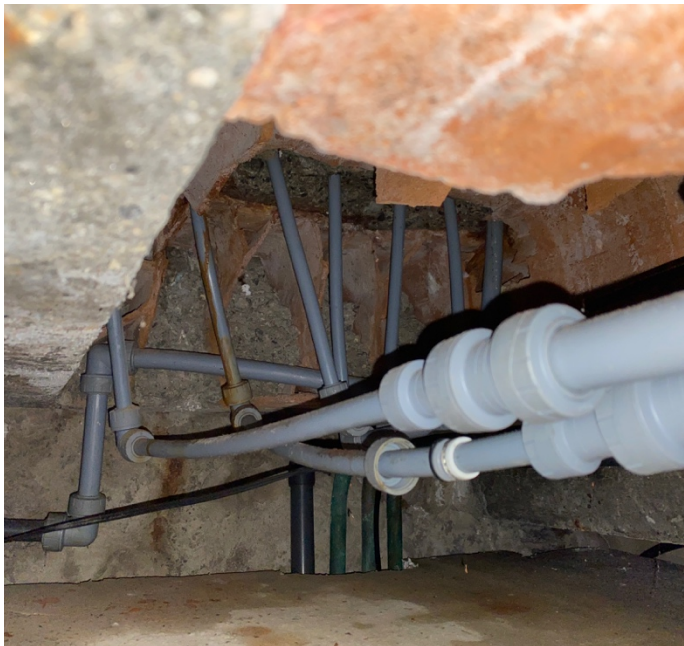
IMG3

Img3 shows some of the visible mains water service pipework which has been replaced throughout the riser and img4 shows the general condition of the meter cupboard.

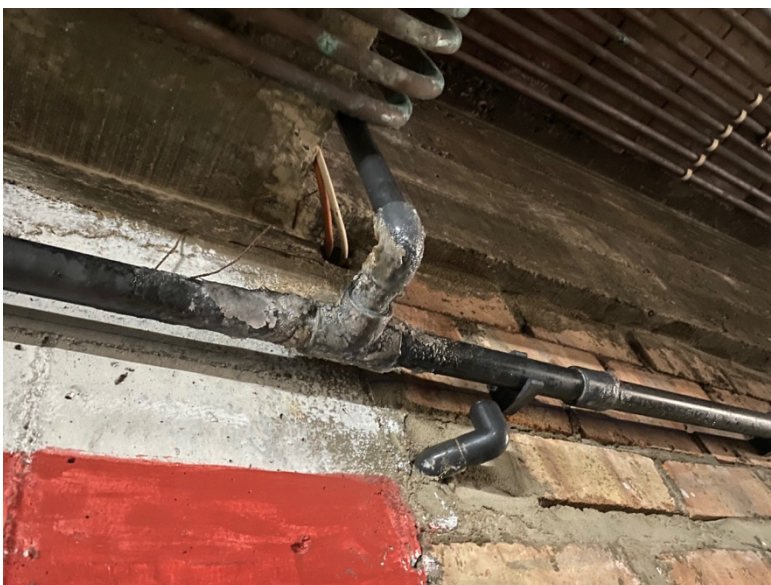
IMG5

There is also a few small leaks on the salt mains in the garage area which is in PVC pipework. This pipework would have to be cut out and replaced (img5).

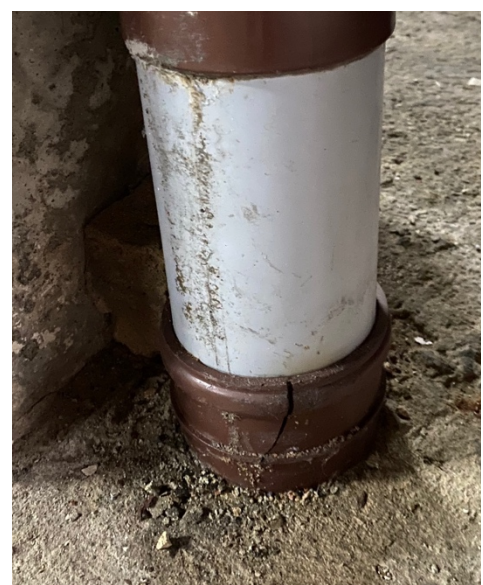
IMG6

Within the garage, the foul and drainage pipework is generally in good condition although one cracked collar was discovered (img6)

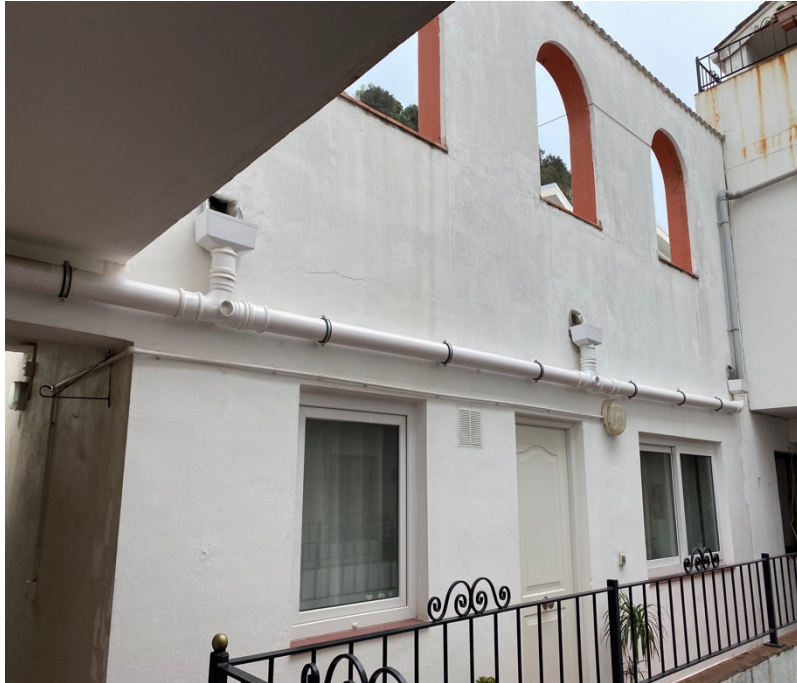
IMG7

Generally the guttering and downpipes are in good condition (img7&8) and showing no obvious signs of damage. Internal surface drainage channels and pipework looks to have been changed fairly recently and are clear of blockages.

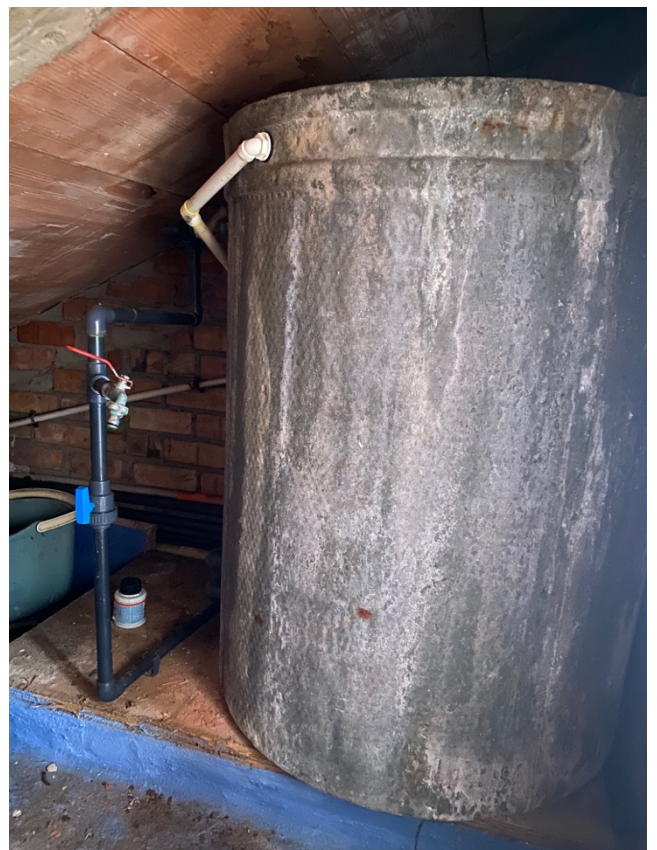
IMG9

I believe the salt tank in the roof area (img9) contains asbestos. This would need confirming by an specialist, however, if it is confirmed then this should be replaced with a polyethylene tank or similar. The connecting pipework and fill valve look relatively new and are of good quality. The tank capacity is around 550litres.
